FEENEY TEST REPORT

SCOPE OF WORK FM 4473 IMPACT RESISTANCE TESTING OF AWNING

REPORT NUMBER J7078.01-801-44-R0

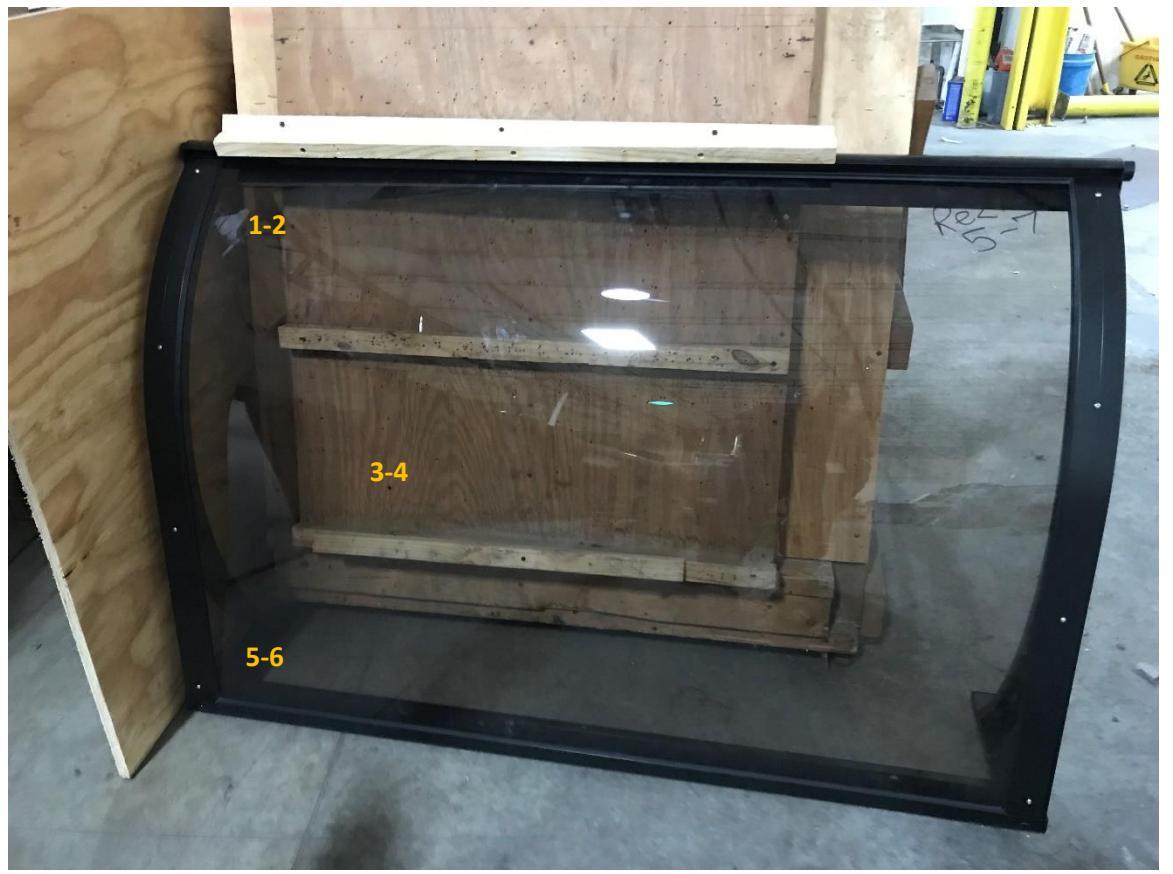
Photo No. 1 Specimen Anchored to Test Deck (Location of Impacts Shown by Numbers)

Installation of the tested product was performed by Intertek. The 59" x 42-1/2" specimen was anchored to a 60" x 36" wood deck by bracing the awning against it and securing it in place with wooden battens fastened with #8 2-1/2" wood screws.

TCSC Offic #								
	MISSILE VELOCITY	ORIENTATION	WEIGHT		ENERGY			DECLUTC
IIVIPACI	m/s (tps)		g (lag)	mm (in.)	π-ΙD		UBSERVATIONS	RESULIS
1	32.7	Vertical	64.8	50.80 (2.00)	25.57	Top left corner, 6"	No visible cracking	Pass
